# Cost-Effective, Patient-Centric, and Innovative Repurposing of a Broken Lingual Arch Space Maintainer: A Case Report

**Introduction** Premature loss of primary teeth due to caries or trauma can cause space discrepancies leading to malocclusion and other dental issues. Space maintainers are essential for preserving the arch space until the eruption of the permanent teeth. This case report presents an innovative modification of an existing space maintainer to address clinical challenges, improve patient outcomes, and reduce costs.

**Case Report** An 8-year-old female presented with a broken lingual arch space maintainer impinging on the lingual mucosa. Clinical examination revealed nonrestorable teeth 84 and 75 that required extraction. Radiographs showed tooth 34 erupting soon and tooth 45 delayed. Owing to financial constraints, the existing appliance was modified by lingually cutting and adapting the wire to the distal surface of the canine. The appliance was cemented using Type I Glass Ionomer Cement in a single visit. After 6 months, tooth 35 erupted normally, without impaction.

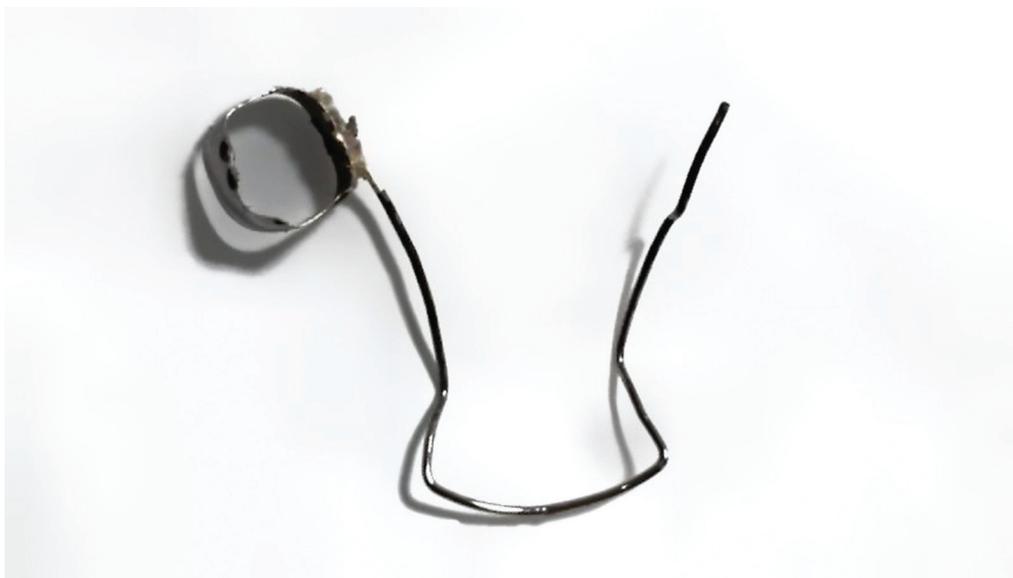
An 8-year-old female presented to a rural center under the flagship of A. B. Shetty Memorial Institute of Dental Sciences, Mangalore, Karnataka, India, with a complaint of a broken lingual arch space maintainer impinging on the lingual mucosa of the lower anterior teeth. **►Fig. 2** the patient's medical history was unremarkable and she had no known allergies.

The patient presented with a broken lingual arch space maintainer at the solder joint on one side of the appliance. The broken appliance was decemented and the remaining luting cement was thoroughly cleaned. The bands on both sides were removed and the tooth was meticulously cleaned to ensure that all residual luting cement was eliminated, thus maintaining adequate oral hygiene. Topical fluoride varnish was applied to prevent decay due to decalcification caused by placement on the banded teeth.<sup>12</sup> The patient was advised to have the lingual arch refabricated; however, owing to financial constraints, the parents refused to opt for a new space maintainer.

**Fig. 2** Broken lingual arch.

Given that sufficient wire remained, excess wire was cut at the midpoint. The wire was then adapted to the distal surface of the canine from the lingual aspect, in contrast to the traditional buccal adaptation observed in Mayne's appliance.<sup>13</sup> This lingual adaptation was chosen to reuse an existing appliance while ensuring better stability and comfort for the patient. Following wire adaptation, the occlusion was meticulously checked to ensure that there were no discrepancies or high points that could affect the patient's bite or comfort.<sup>14</sup> Finally, the modified appliance was cemented using the luting consistency of Type I Glass Ionomer Cement (**►Fig. 2**; **►Fig. 3**).
